World Oil[®] HPHT
DRILLING, COMPLETIONS & PRODUCTION CONFERENCE

Erosion-corrosion Assessment of Steels in HPHT Sweet Corrosive Environment

Md. Aminul Islam, Roy Lee and Rob Hui

National Research Council of Canada

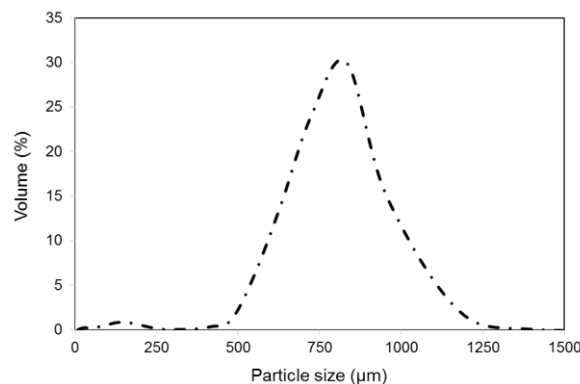
SEM micrograph of Filter 16-30

Average particle size 724-823 µm

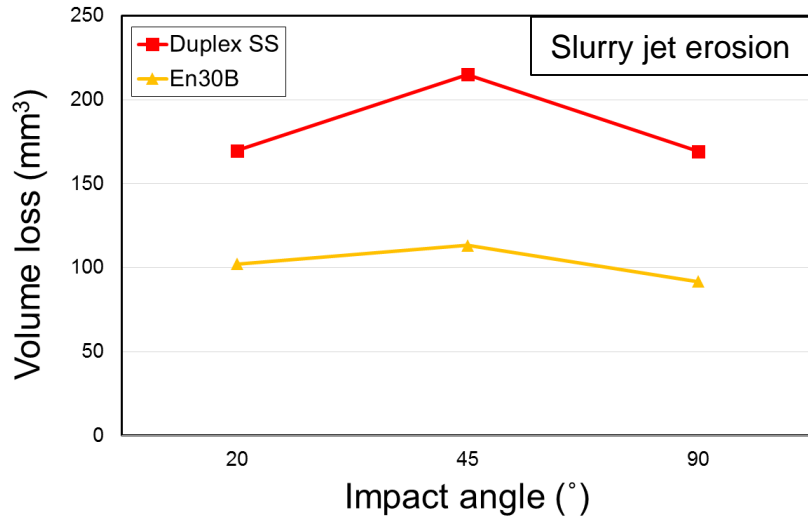
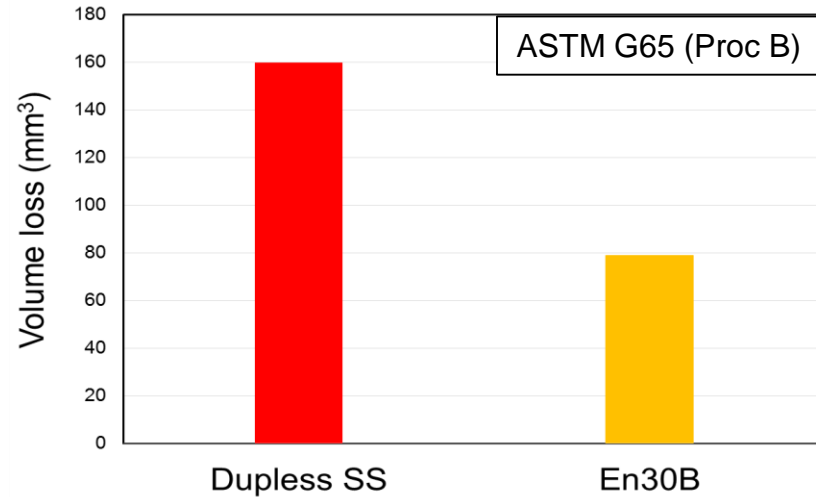
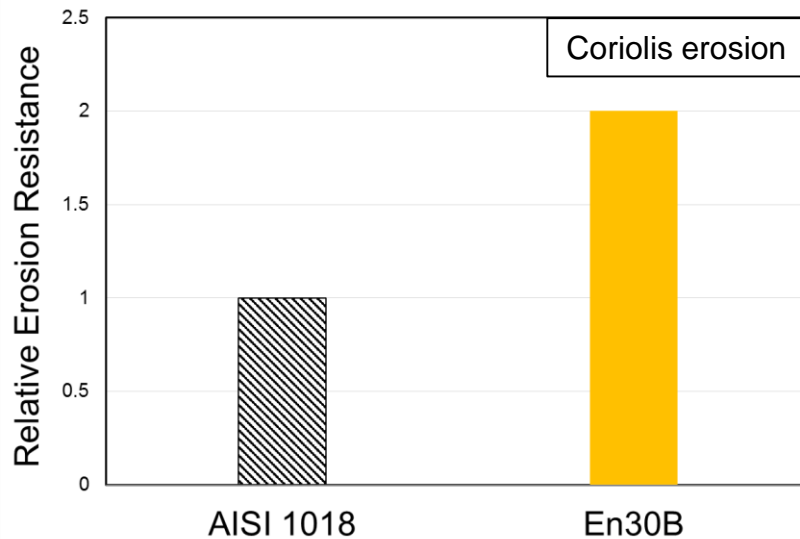
- Duplex SS exhibits inferior slurry jet erosion resistance at all impact angles
- En30B displays better low stress abrasion resistance than Duplex SS
- En30B shows better erosion resistance than AISI 1018 @23°C

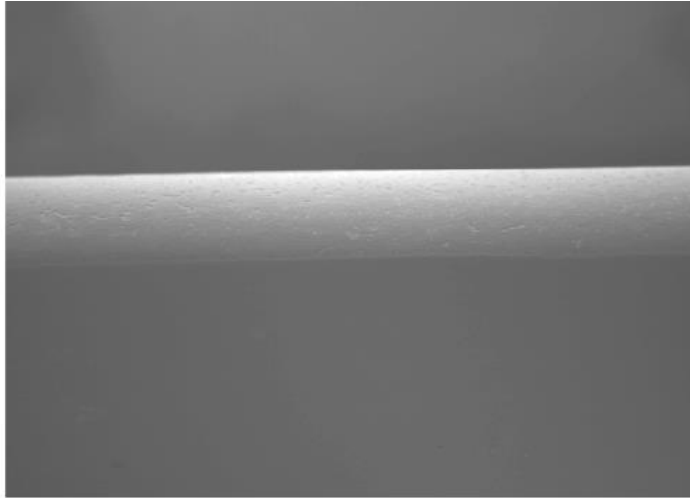
EDS mapping after E-C (X-section)

Electron Image 1

O Ka1

Mo La1

Fe Ka1

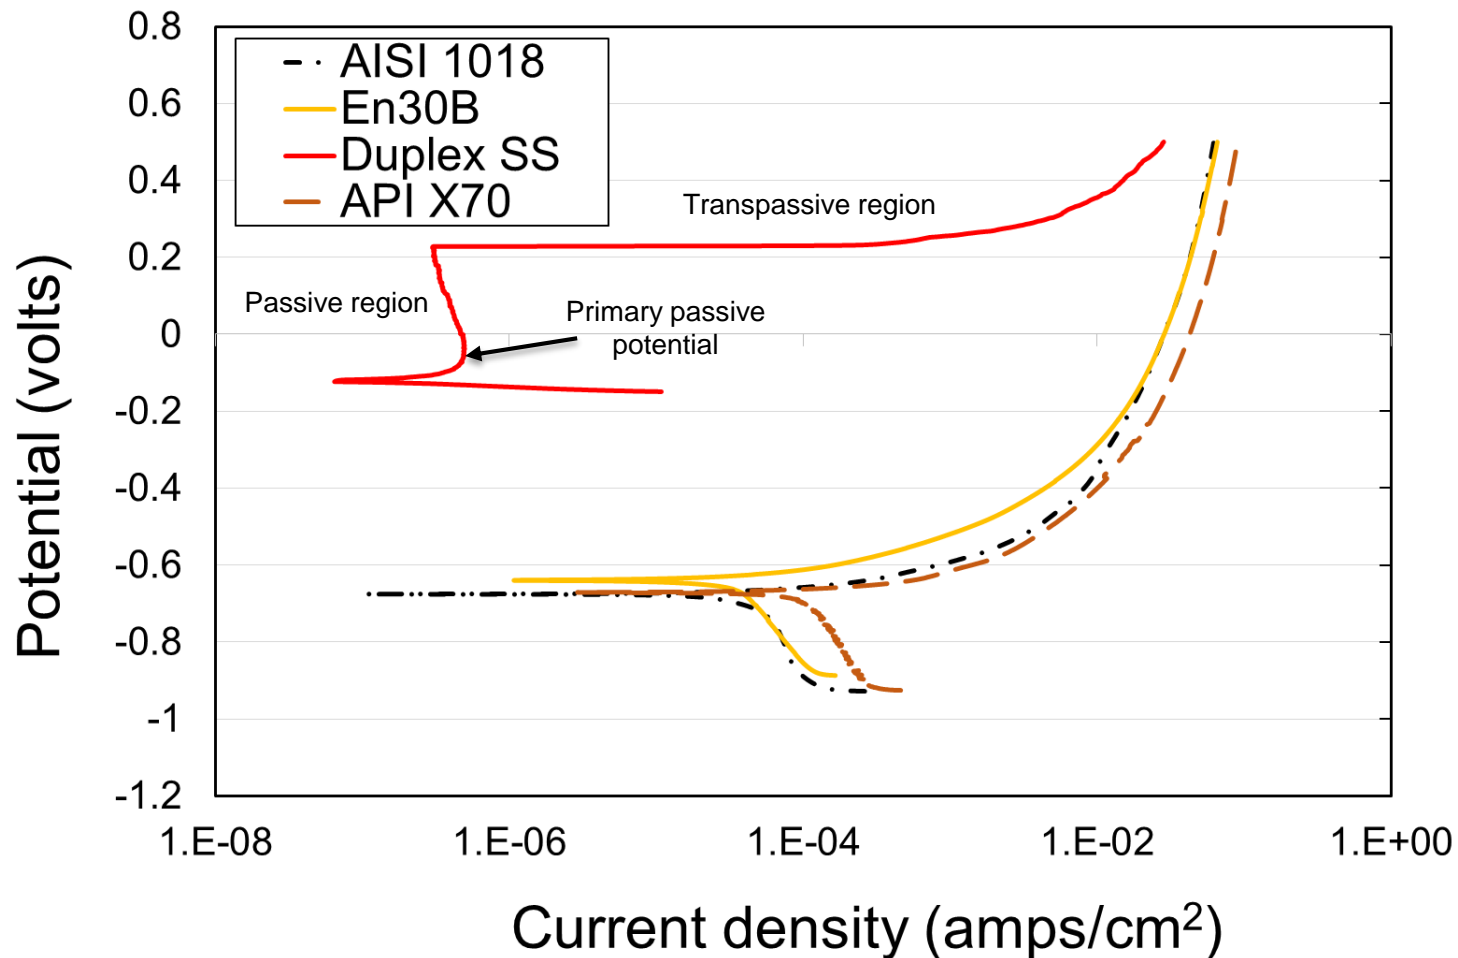
Electrochemical corrosion

Materials	E_{corr} (mV)	I_{corr} ($\mu\text{A}/\text{cm}^2$)	Corrosion rate (mm/yr)
En30B	-639.7	34.08	0.3969
AISI 1018	-675.8	40.82	0.4754
API X70	-672.2	64.75	0.7540
Duplex SS	-121.7	0.11	0.0012
